Infrastructure development and Local Environment Monitoring Committees in Bolivia

Bolivia | 2012

Case Study

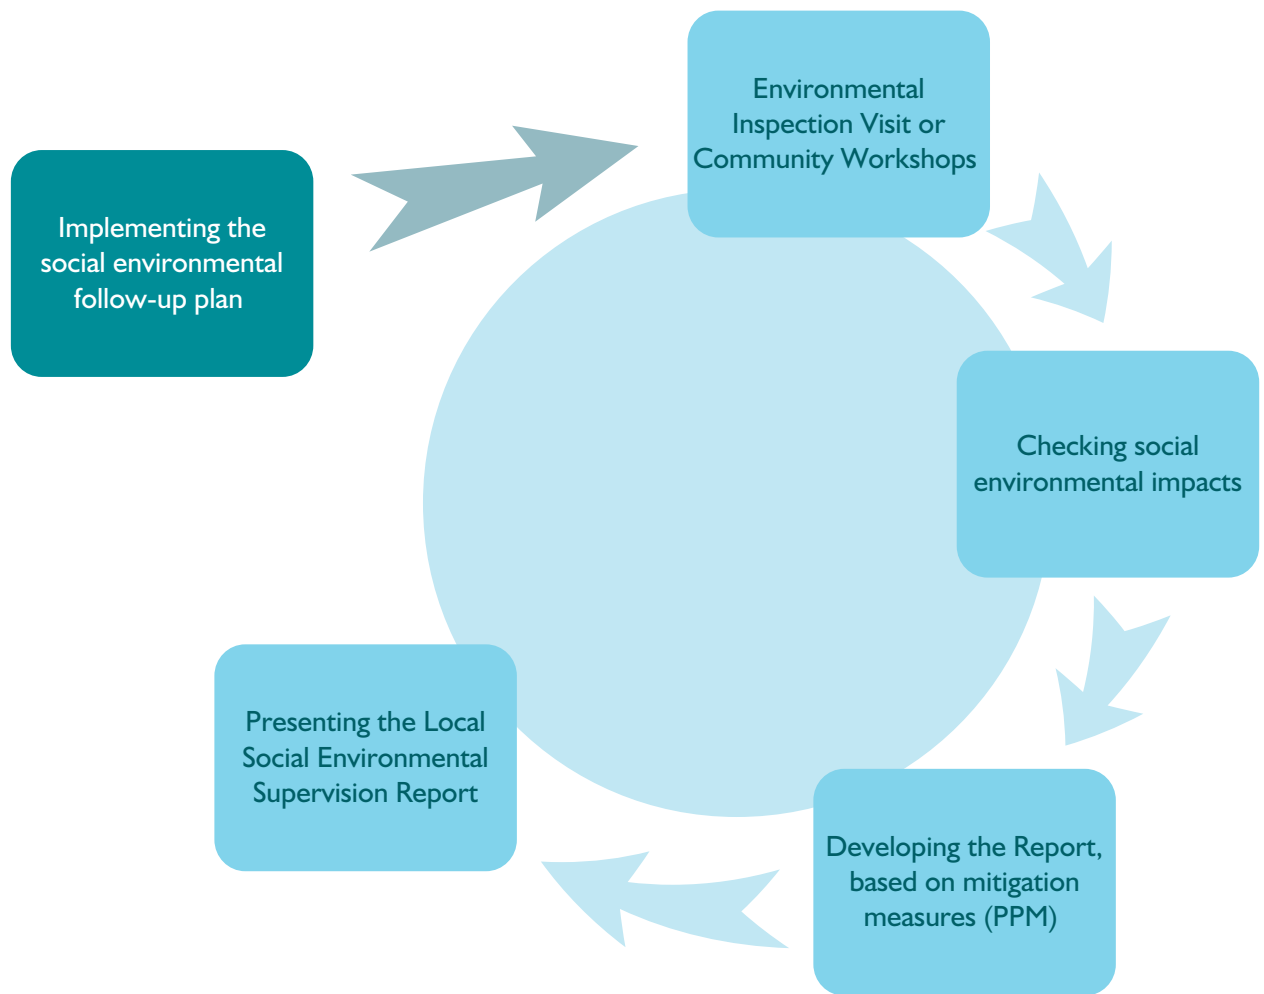
Chart 4: Yucumo – Rurrenabaque Highway Complementary Social Environmental Follow-up Report

Steps to apply the Social Environmental Follow-up Plan

Source: CLMA Yucumo – Rurrenabaque with support from the Ecology Institute / UMSA and FUNDESNA, 2012.

In that regard, local Environmental Assessment Committees have presented three complementary environmental follow-up reports to date concerning compliance with prevention and mitigation measures to the Deputy Minister of the Environment, SERNAP, the Bolivian Highway Administration, and the General Public Attorney.
